BioSoft Toolbox® for Swine

Scanning for Marbling

Scanning Swine for Marbling

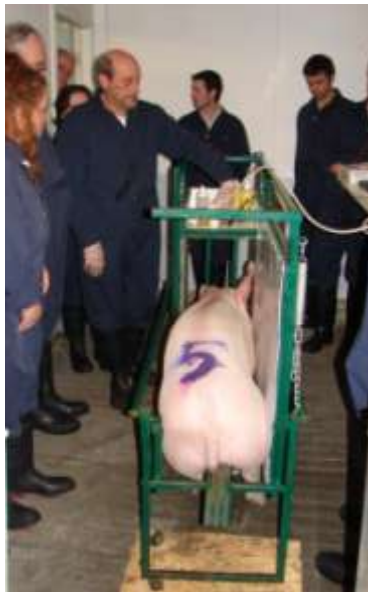
Figure 3. Restraining crate for scanning pigs.

Some technicians have developed a mechanical bar that goes between the legs of the animal (from front to back) and can be raised to elevate the pig off of its feet. An example crate with a raising bar that was developed by swine researchers in Canada is shown in Figure 3. This is an extremely useful innovation that contributes not only to capturing excellent quality images, but to the safety of both the pig and the technician. This innovation also cuts down considerably on the amount of time required to scan the pig, and minimizes the stress level of the pig.

Quality ultrasound images can only be captured from pigs that are properly restrained. The pig must be confined to a crate that will restrict its forward, rearward, and lateral movement. The pig must be also be restrained so that it is not able to raise its head above the top of the crate or to climb out of the crate. Quality images can only be captured when the pig is near motionless.

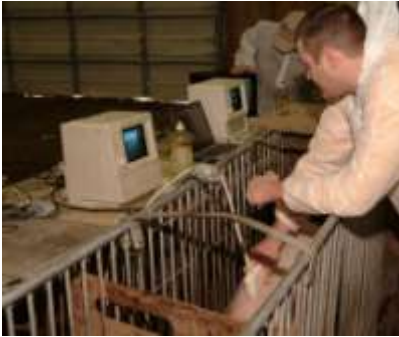
Figure 4. Scanning crate and equipment setup.

Technicians may find it convenient to position the crate and a table for the ultrasound equipment as shown in Figure 4. This configuration allows the technician to both observe the image that is being captured and the positioning of the transducer on the back of the pig at the same time.

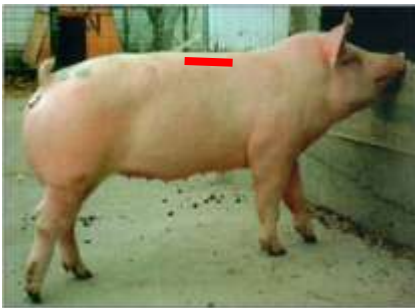
Figure 6. Position of the transducer for the IMF image.

Figure 5 is the skeleton of a mature porcine that has 14 ribs with the most posterior rib numbered as 14. The red colored bracket is located over the 12th through the 9th ribs, and this is the position for placing the transducer for the IMF image. The red line in Figure 6 is showing the similar position.

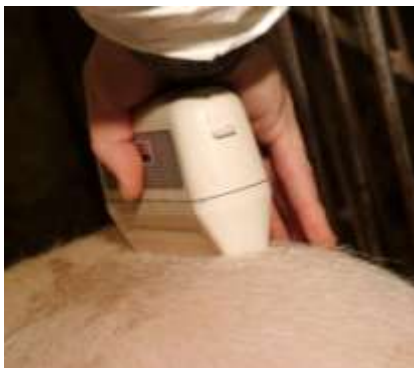
Figure 7. Hand position for holding the transducer.

Technicians may have their own preference for holding the transducer when scanning for IMF, however, the method shown in Figure 7 allows a significant amount of control. The transducer is cradled between the thumb and the index finger, and grasped just behind the cord that exits the transducer on the top side. Notice that the fingers are touching the skin of the animal and are used to help steady the transducer as it is moved laterally at the top to reduce the magnitude of echoes (if present in the image).

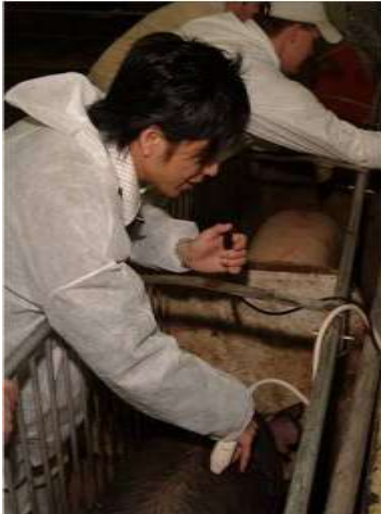
Figure 8. Scanning for IMF.

The ultrasound transducer is to be aligned parallel with the midline of the pig and approximately 5 cm off the midline as shown in Figure 8. The transducer should also be almost perpendicular to the skin surface. For smaller pigs, the transducer may need to be placed closer to the midline at 4 cm and for large pigs further from the midline.

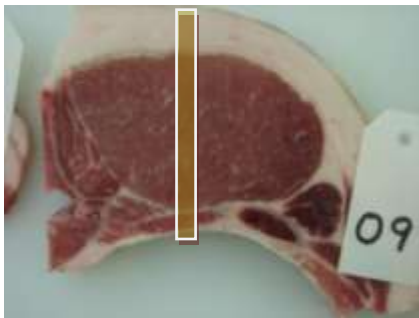
Figure 9. Scanning plane for the IMF image.

The objective is to have the image (called a longitudinal image) captured at the cross-sectional midpoint of the longissimus dorsi muscle as shown in Figure 9. It is also important that the image shows the longitudinal image with a near maximum loin muscle depth.

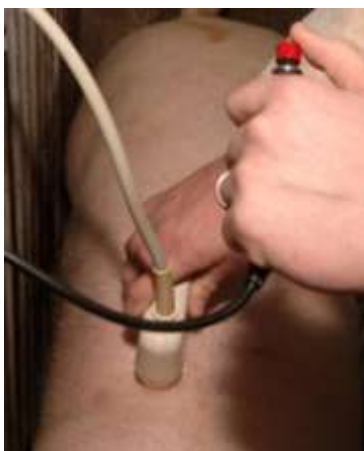
Figure 10. Transducer alignment and freeze switch.

A remote 'freeze' switch can be provided with the Aloka SSD 500V. This switch is held by one hand of the scanning technician, and the transducer is held in the other hand as shown in Figure 10. The technician will be watching the image on the console CRT to determine when the transducer is in the correct location, and when a quality image can be frozen by pressing the freeze switch. If the image is not of good quality, then the image is released by pressing the freeze switch a second time. Images that are not of high quality should never be captured by the BioSoft Toolbox® software.

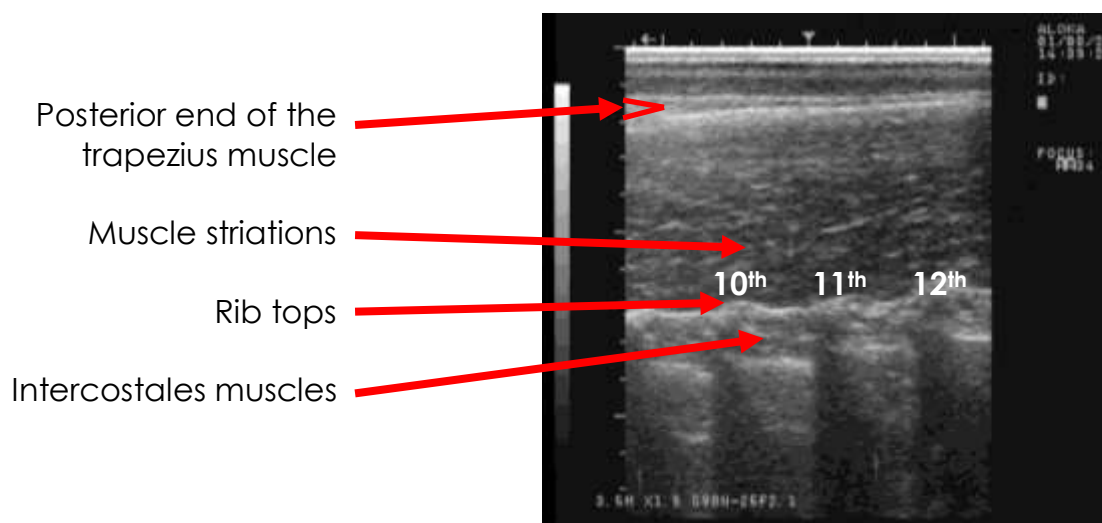
Figure 11. A high quality IMF image.

As shown in Figure 11, the tops of the ribs should be well defined in the image. The intercostales muscles that anatomically attach the ribs together should appear distinct and clear in the image.

The most posterior end of the trapezius muscle should be showing in the image. This end will be used in defining the position of the 10th rib. As the technician drops an imaginary line down from the trapezius end, the line will intersect or come very close to the 10th rib.

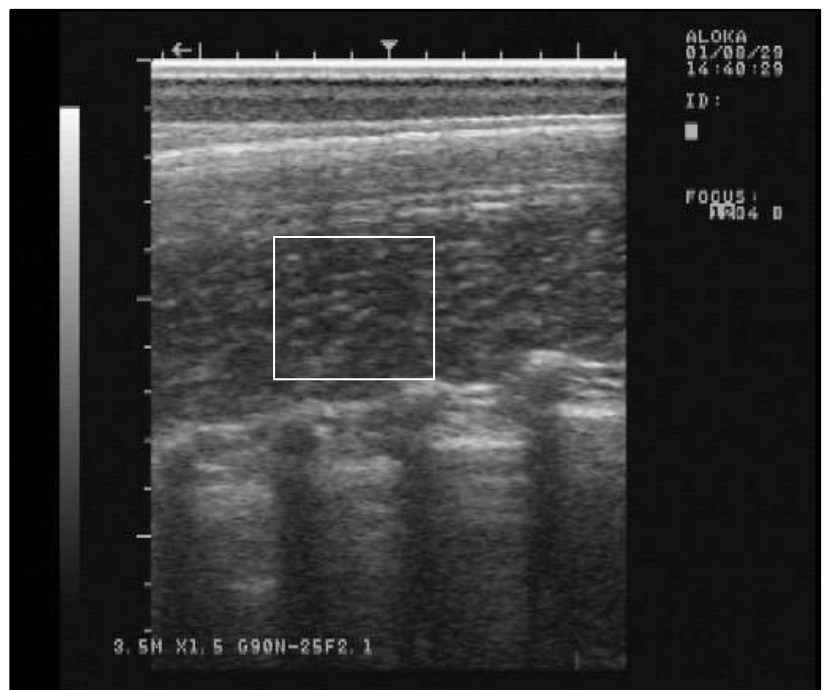
Figure 12. IMF image with region of interest (ROI).

The longitudinal image shown in Figure 12 has a region of interest (ROI) box that has been manually positioned with a computer mouse. This ROI box is positioned almost directly between the 10th and 11th ribs. There is just a very small tip of the posterior end of the trapezius muscle showing in this image. The ROI does not include any rib tops.

The ROI is also located below the artifact echoes appearing in this image. It can be seen that the texture of the image within the boundaries of the ROI box is homogeneous.

Images captured for determination of IMF must be of the quality shown in Figure 12. It is to be noted that this image should have been improved by the technician by minimizing the echoes. However, the echoes do not intersect the ROI, and therefore, they will not affect the accuracy of the IMF determination.

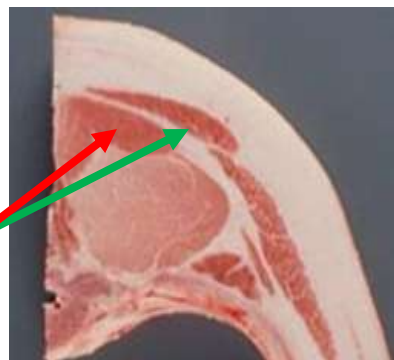
Figure 13. Cross-sectional picture at the 5th rib (photo courtesy of Clint Schwab).

Trapezius muscle

Spinalis dorsi muscle

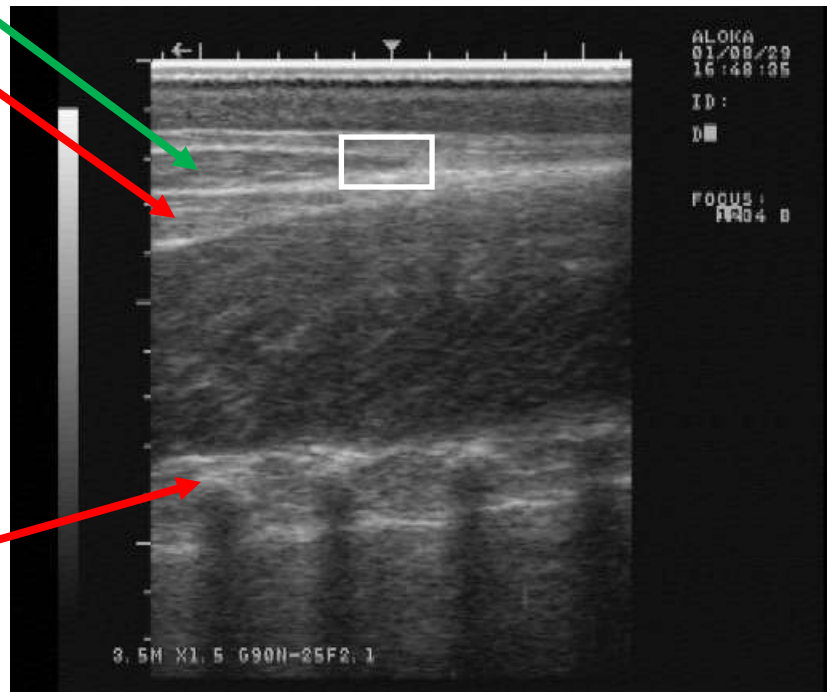
Figure 14. Image with too much trapezius muscle.

The image shown in Figure 14 is taken too far forward on the animal. This is evidenced by the amount of trapezius muscle and the spinalis dorsi muscle that are shown in the image.

A properly collected IMF image will not contain any of the spinalis dorsi muscle and will contain only the posterior tip of the trapezius muscle.

The box shown in the image contains the posterior end of the trapezius muscle.

8th Rib

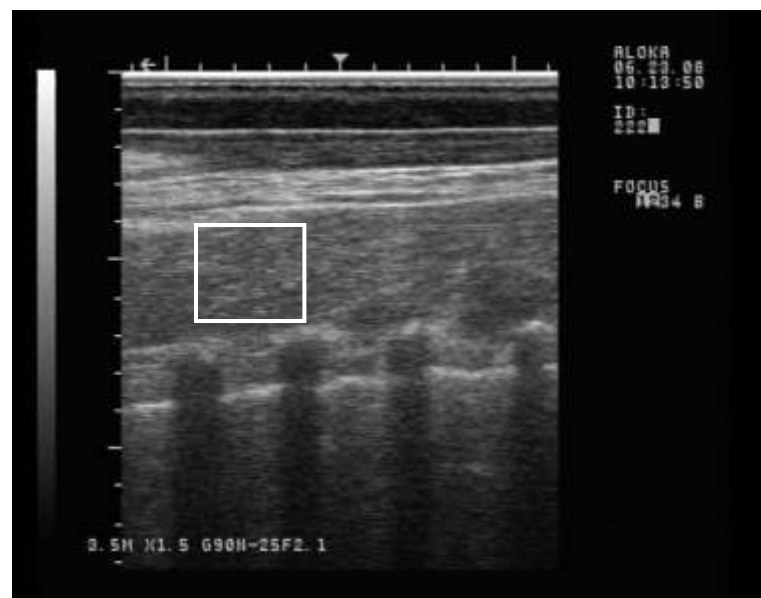
Figure 16. Acceptable Image.

The image shown in Figure 16 is an acceptable image. Just the tip of the posterior end of the trapezius muscle is shown in the image. There are no echoes appearing in the longissimus dorsi (loin muscle) part of this image.

This is a relatively fat pig, with a narrow loin depth. This image will require a smaller ROI than the image shown in Figure 15. The size of the ROI can be changed during the image interpretation process.

Note the consistent texture that appears within ROI.

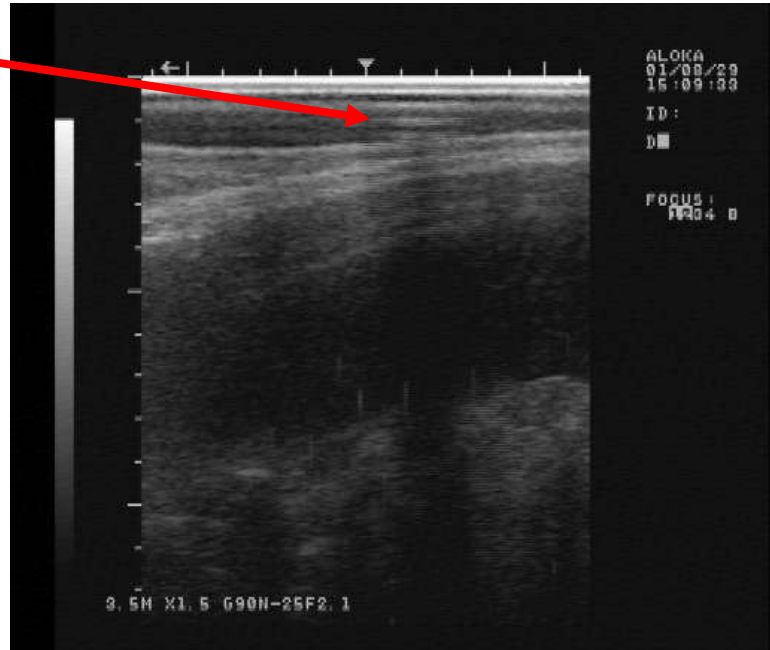
Figure 17. Image with poor contact.

The image shown in Figure 17 has several problems. A major problem is that there is not good contact between the ultrasound transducer and the skin of the pig.

It could be that the pig moved at the instant the freeze switch was depressed. It is also possible that there was not enough couplant applied to the skin of the pig. Images that look like this should not be interpreted for IMF.

This image also has the appearance of being blurred. The rib tops and intercostales muscles are not well defined. This image should not be used to determine IMF.

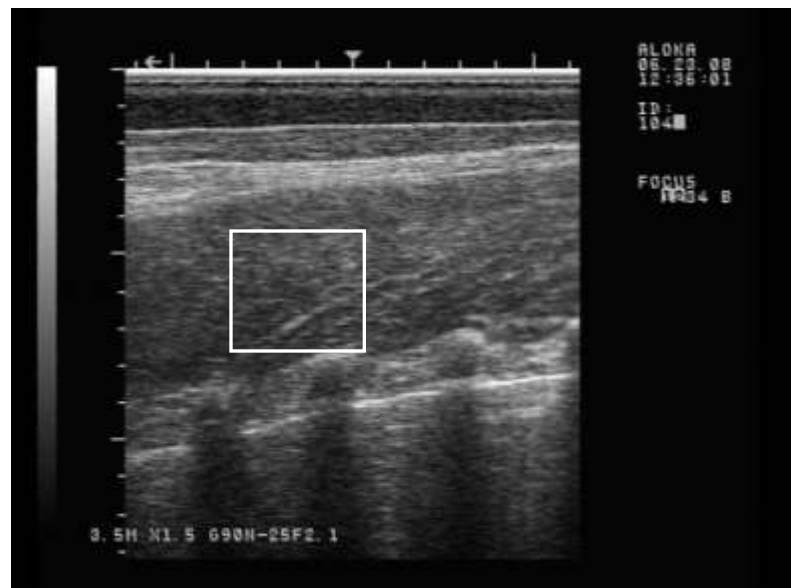
Figure 18. Acceptable image.

The image shown in Figure 18 is of acceptable quality to predict IMF. The posterior tip of the trapezius muscle is easily identified, and there are no echoes in the location where the ROI is positioned.

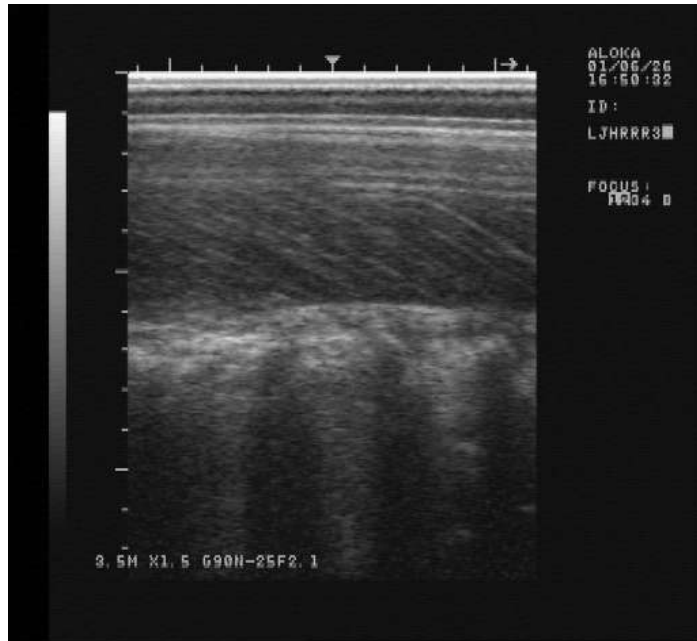
Figure 19. Blurred image.

The image shown in Figure 19 is what is referred to as a blurred image. An unblurred image taken on the same pig is shown in Figure 20. Sometimes blurring is very subtle, and only the experienced eye can determine that an image is blurred.

Having an unblurred image on the same animal makes the determination much easier. In this case, one can see that the image in Figure 20 is much more crisp and sharp than the image shown in Figure 19.

Blurring occurs when there is movement of the transducer at the same time the image is frozen. This can be caused by movement of the pig, or because the technician moved the transducer at the instant the freeze switch was pressed. Blurred images should never be interpreted for IMF as the result will not be accurate.

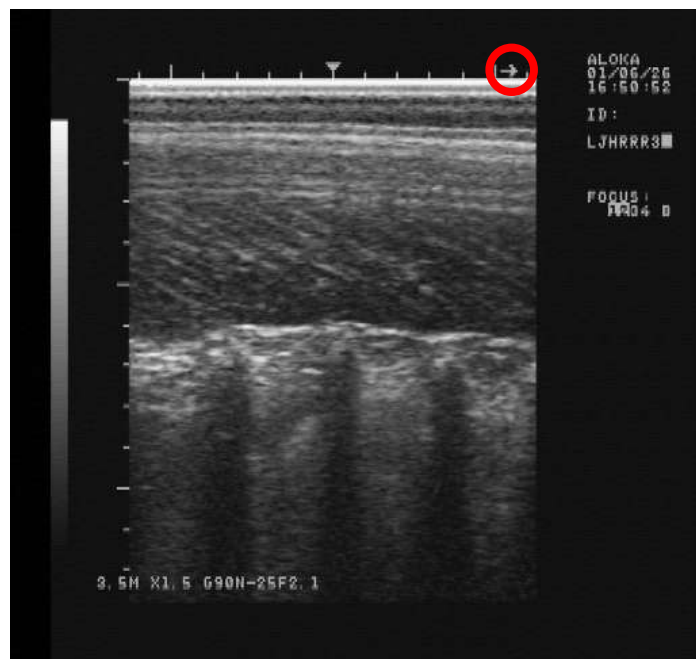
Figure 20. Image without blurring.

It is to be noted that there is no trapezius posterior end showing in the image of Figure 20. So even though the image is not blurred, it is not a good image because without the trapezius end showing, it is impossible to determine which is the 10th rib. It is suspected that this image is collected too posterior on the animal, and the transducer is over the 14th, 13th and 12th ribs (the 14th rib being the left-most rib).

There are echoes appearing in the image in Figure 20, however, the loin depth is sufficient for position of the ROI without any problems.

Note the direction of the diagonal muscle striations. They are going from left to right in the image meaning that the head of the pig is to the right of this image. The technician has reversed the direction of the probe to capture these images (see the red circle).

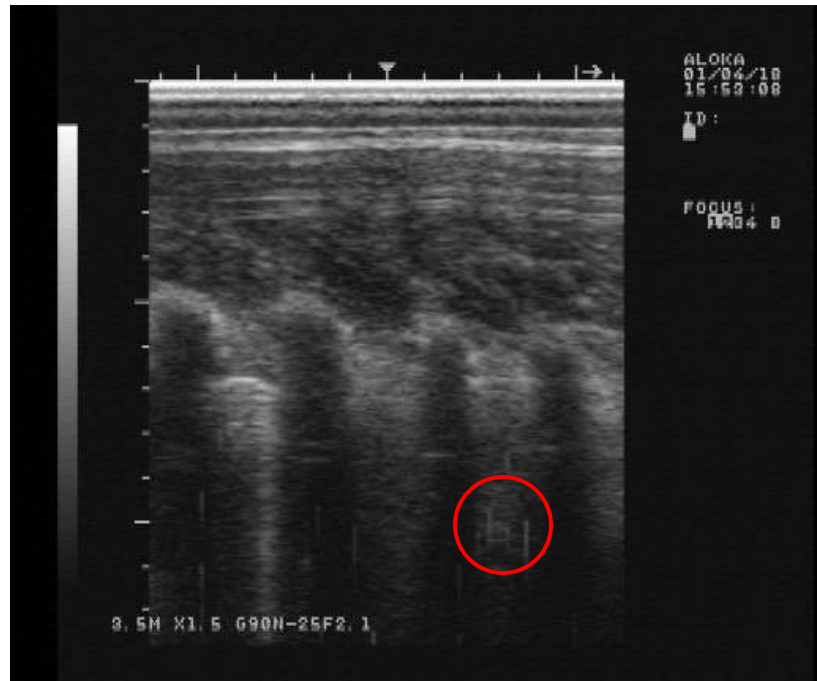
Figure 21. Image with echoes and interference or noise.

The image shown in Figure 21 has echoes within the region where the ROI should be placed. The echoes are caused by the strong interface reflections between the fat layers.

Echoes can be minimized by slightly tilting the transducer on the surface of the skin and so that the alignment is not directly perpendicular.

This image is also showing some type of signal interference or noise streaks. These streaks can be seen in the dark regions and in the shadow of the rib tops. Some of the streaks are circled in red. Images with interference should not be interpreted for IMF.

This image is also missing the tip of the trapezius muscle.

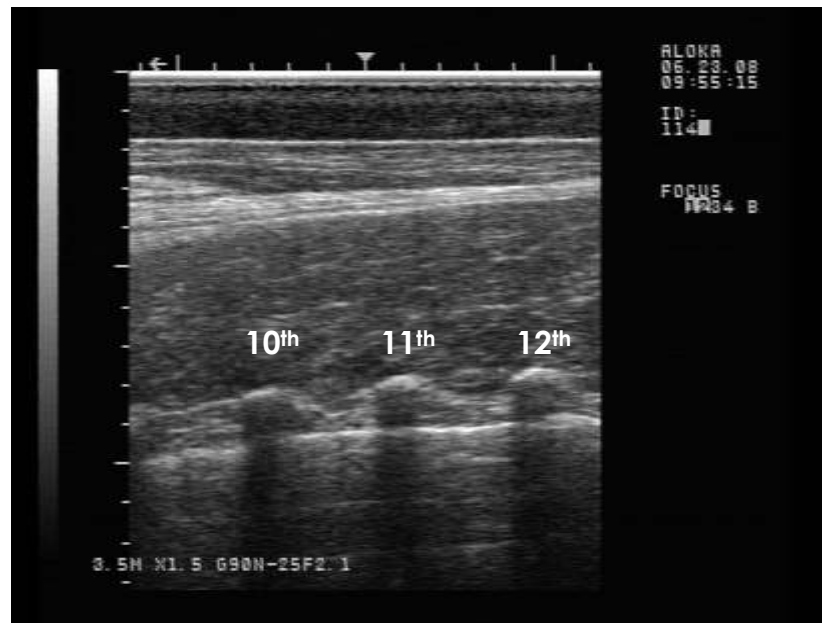
Figure 22. Acceptable image.

The image shown in Figure 22 is an acceptable image. The posterior end of the trapezius muscle is showing in the image. The rib tops are clearly defined along with the intercostales muscles.

The scanning technician should use the image shown in Figure 22 as their ultimate image quality objective. With a set of images like this for every pig, the accuracy of IMF prediction will be enhanced.

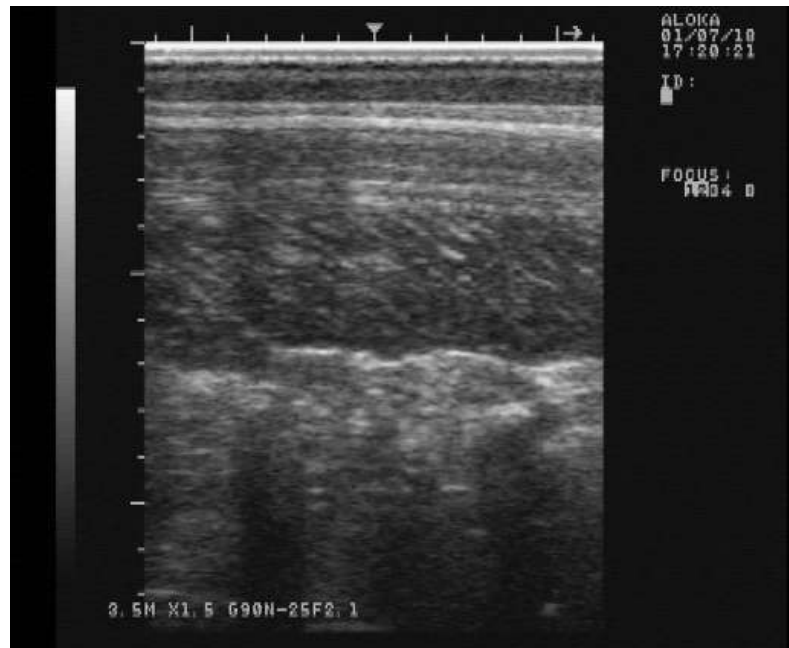
Figure 23. Image with poorly defined rib tops and intercostales muscles.

The image shown in Figure 23 has several problems. It has two dark regions, indicating that there was not sufficient couplant between the transducer lens and the skin of the animal.

The rib tops and intercostales muscles are not well defined in this image. There is no evidence of the trapezius muscle, and the technician should have minimized the echoes.

This image should not be used to determine an IMF value.

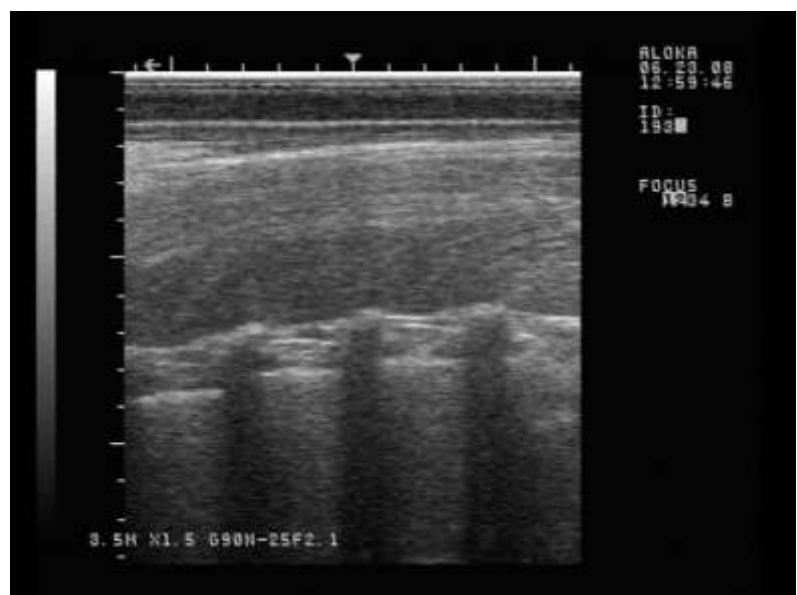
Figure 24. Acceptable image.

The image shown in Figure 24 is an acceptable image and can be used to determine IMF. There is some evidence of echoes in this image, so a small ROI should be used so that the echoes do not intersect or appear within the ROI.

The posterior end of the trapezius muscle is present in this image. The rib tops and intercostales muscles are well defined.

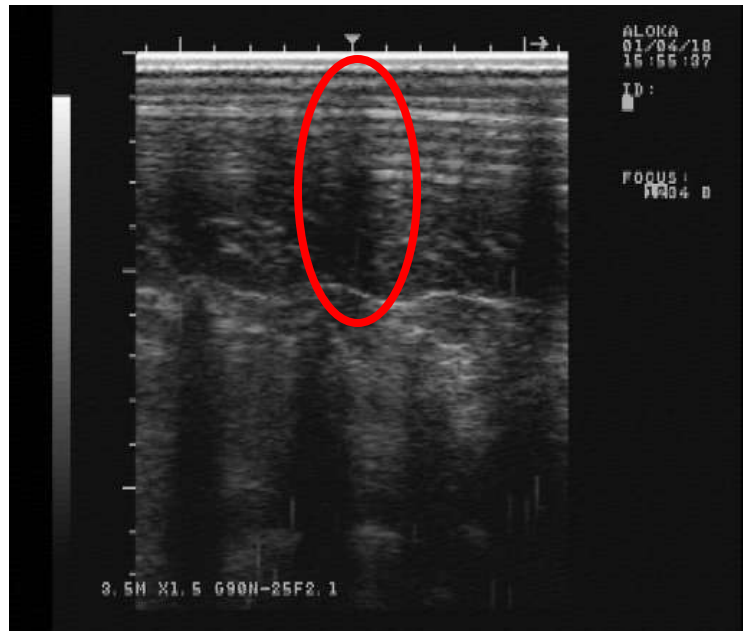
Figure 25. Image with dark regions.

The image shown in Figure 25 has several problems. One of the major problems is that there are several dark regions. One of the dark regions is outlined with the red oval.

Dark regions can be caused by several different things. Usually, it means that there is not enough couplant between the transducer lens and the skin of the animal. It could also mean that the skin is dirty and needs to be cleaned. Two other reasons include that one or more transducer crystals may not be functioning or that excessive hair is causing attenuation of the ultrasound signal.

Other problems in this image include excessive echoes and some type of noise or electrical interference. Also, the posterior tip of the trapezius muscle is not showing in the image.

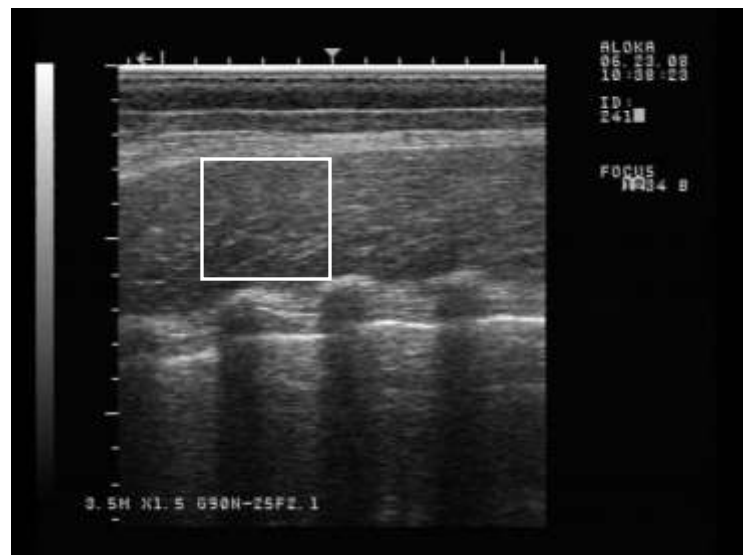
Figure 26. Acceptable image.

The image shown in Figure 26 is an acceptable image and can be used to determine IMF. The posterior end of the trapezius muscle is present. The rib tops and the intercostales muscles are clearly defined. The region where the ROI is placed contains a very consistent and homogeneous texture.
